Yorktown Beach 2003-2005, with Hurricane Isabel Impacts

January 2005

A report obtained under contract with York County, Virginia

Virginia Institute of Marine Science
School of Marine Science
College of William & Mary
Gloucester Point, Virginia

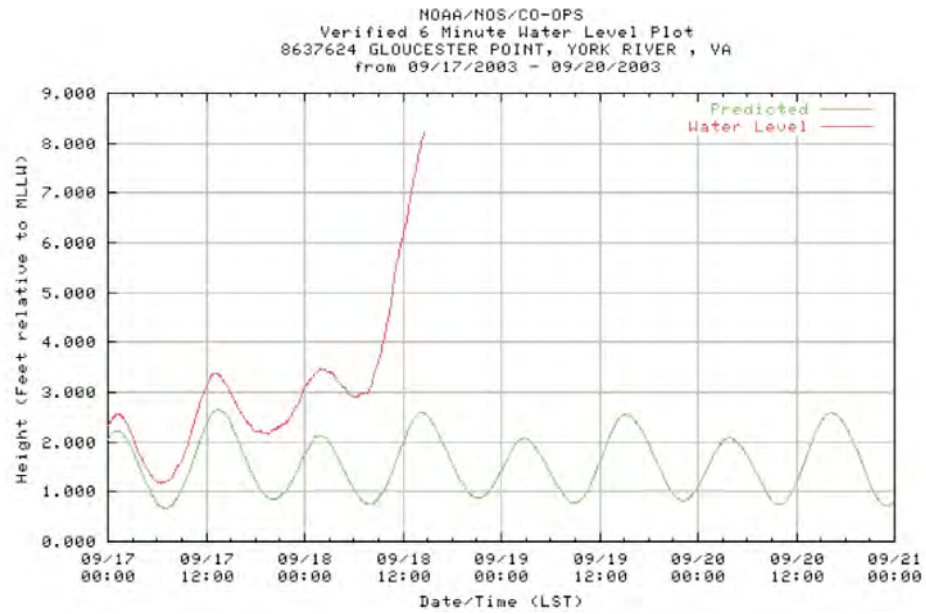
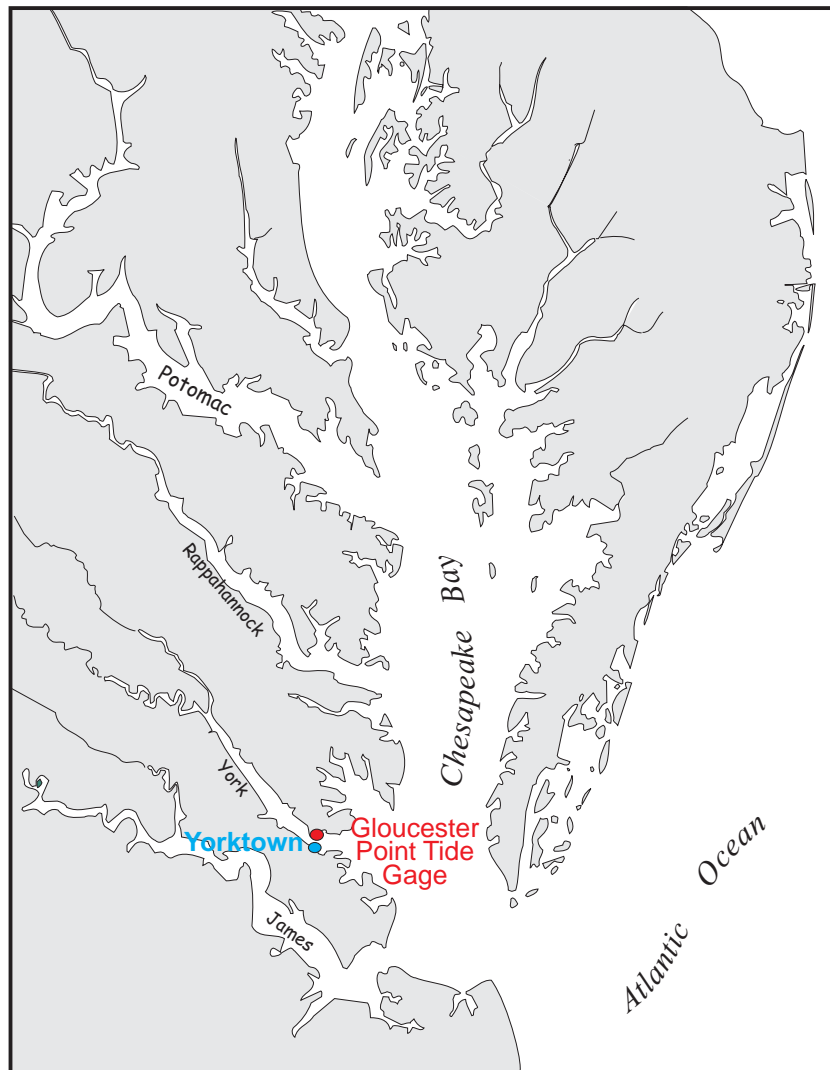
Figure 2. Location of Yorktown in relation to the Gloucester Point Tide gage and the gage's tide record during Hurricane Isabel.

Around the Bay, similar impacts were recorded by tide gages. However, the gage at Gloucester Point across the river from Yorktown was destroyed during the storm before the peak water level was reached ([Figure 2](#)). This tide gage stopped recording at 8.5 ft MLLW during the storm. Maximum measured stillwater level across the river at Yorktown was 8.6 ft MLLW with the trash line indicating the water plus waves was at 12.5 ft MLLW. That is a surge above the mean range (2.4 ft) of 6 ft with additional 4 ft waves. Weather data provided by instruments atop VIMS' Byrd Hall showed that maximum sustained winds on the campus reached 65 mph, with 90-mph gusts. The barometer bottomed out at 29.2 inches, with a rainfall accumulation of about 2.2 inches (VIMS, 2003).

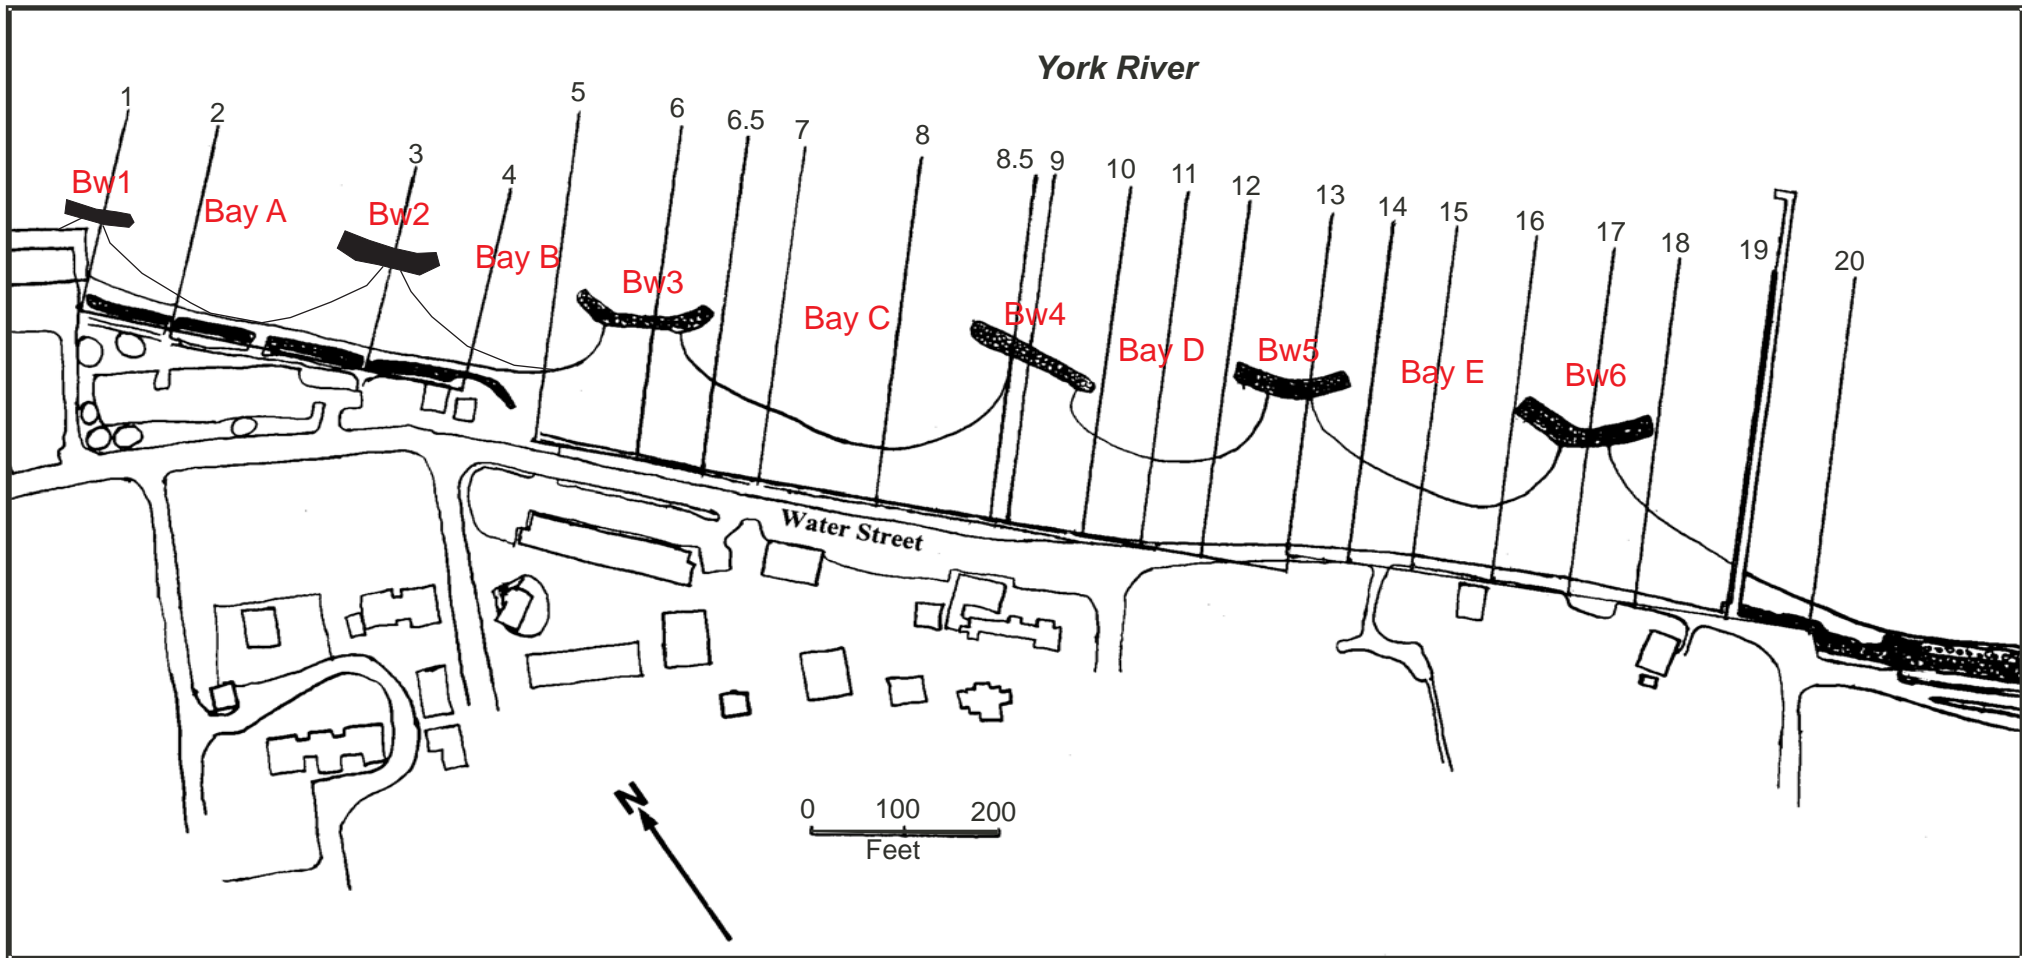
Figure 3. Yorktown Public Beach survey baseline.

Shoreline Studies personnel from VIMS began monitoring the beach at Yorktown in the spring of 1985. Due to a storm event, the baseline was reset in 1986 and slightly altered in September 1993 ([Figure 3](#)). In September 1994, two additional profile lines were added, 6.5 and 8.5. During construction of the downriver breakwaters in Phase II, VIMS personnel added six new profile lines (profiles 15-20). The baseline for profiles 5 to 11 was re-established on 4 May 2000 after the completion of the walkway. For additional information, see Milligan *et al.* (1996). Beginning in 2003, new methodologies were established for surveying the beach. The Trimble 4700 Real-Time Kinematic Global Positioning System (RTK-GPS) was used to set site control and acquire beach and shore data. The 4700 receiver utilizes dual-frequency, real-time technology to obtain centimeter accuracy in surveying applications. In addition, a Trimble 5600 Robotic Total Station was used to acquire data in the nearshore. The combination of these new instruments allows for a more detailed mapping of the beach and nearshore in a shorter amount of time.

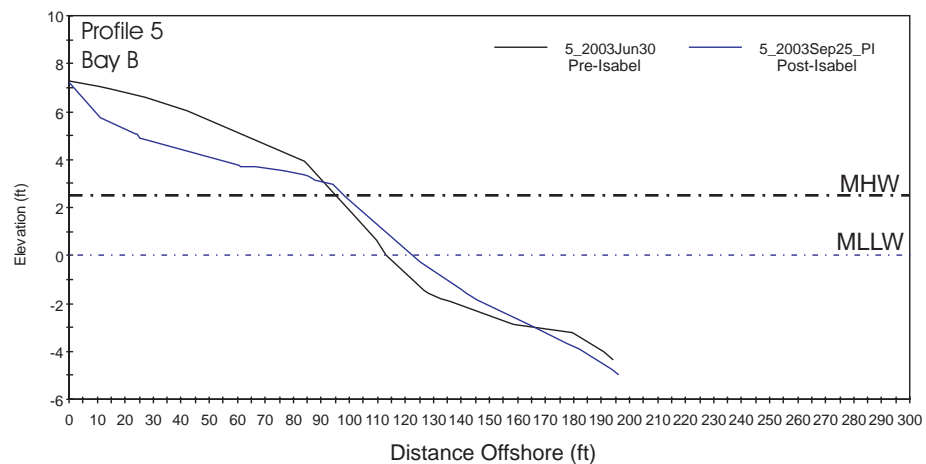
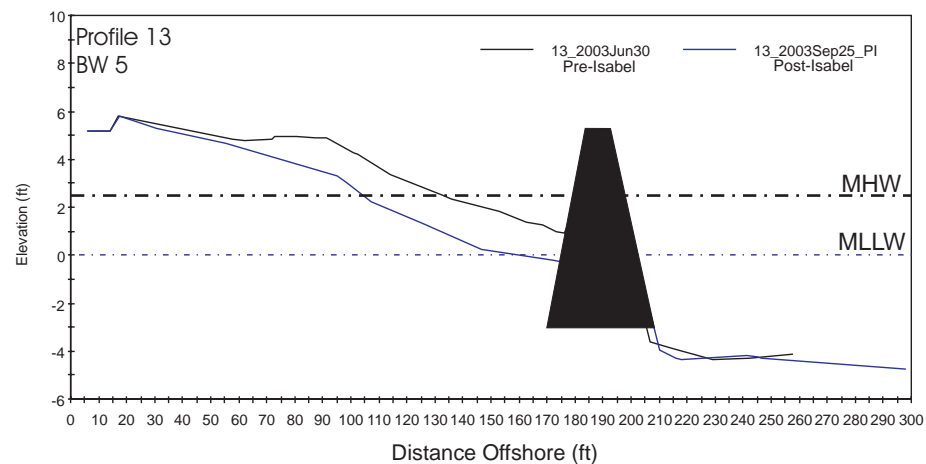
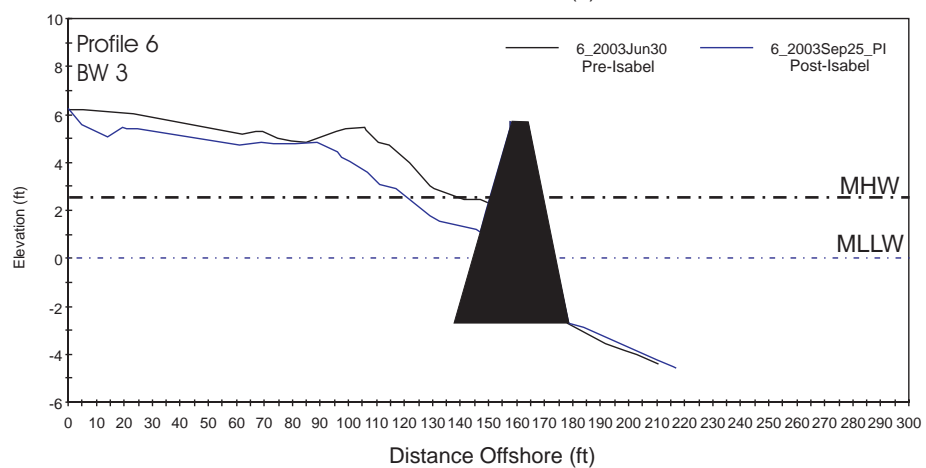
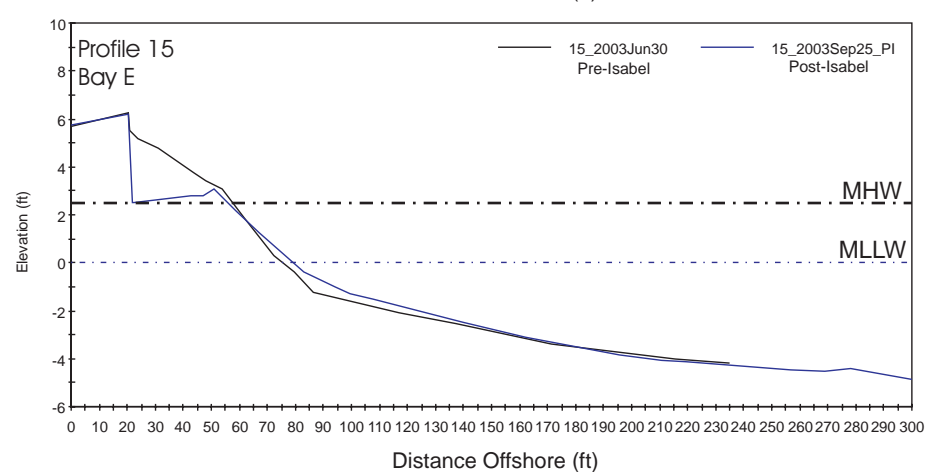
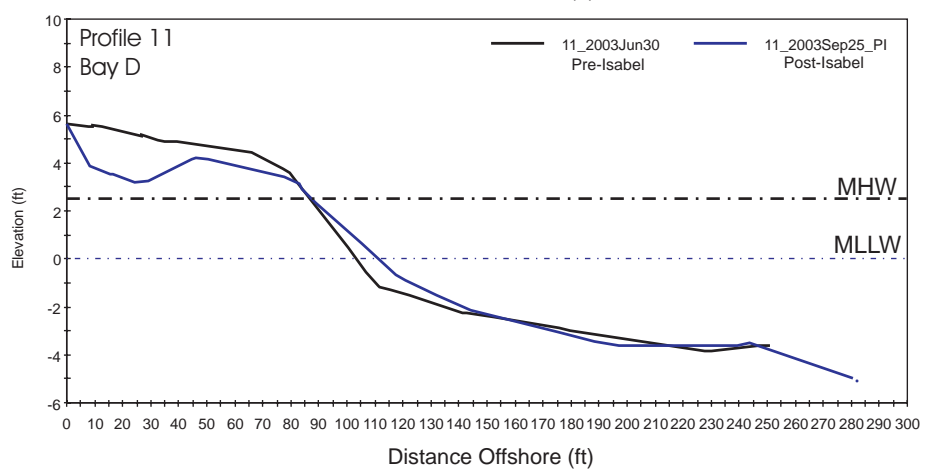
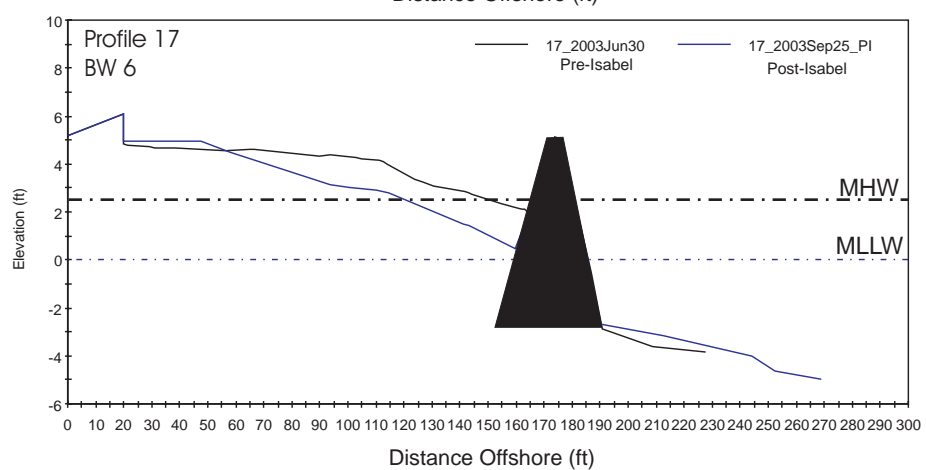
Figure 4. Selected pre- to post-Hurricane Isabel profile plots.

The plots of each profile and all dates are shown in [Appendix B](#). Selected typical profiles before and after Hurricane Isabel impacted the shore show cross-sectional changes as a basic cut and fill in the embayments ([Figure 4](#)). Shearing occurred across the top of the tombolos behind each breakwater. Some sand was lost to the offshore after the storm but the County filled the beach to its pre-storm profile shortly after the hurricane. The cross-sectional profiles were analyzed in sections including the volume change above MHW (defined as +2.5 ft MLLW), volume between MHW and MLLW, and volume between MLLW and -4 ft MLLW ([Table 1](#)). Volume calculations indicate that all of the sand loss occurred above MHW during the storm. In addition, much of the sand was deposited in the nearshore since about 600 cy could be accounted for in that region. When the recovery beach fill was placed, most sand also was placed above MHW with little being deposited on the beach face. In fact, some of the sand in the nearshore was lost as the sand deposited by Isabel moved. The post Isabel sand replacement is shown for selected profiles in [Figure 5](#). The sand had begun to equilibrate by July 2004 and continued into 2005 as sand shifts around each embayment and behind the breakwaters ([Figure 6](#)). The loss of sand above MHW between December 2003 and July 2004 is the resulting movement of sand from areas that may have been “over-filled” during the overall nourishment of the beach after the storm.

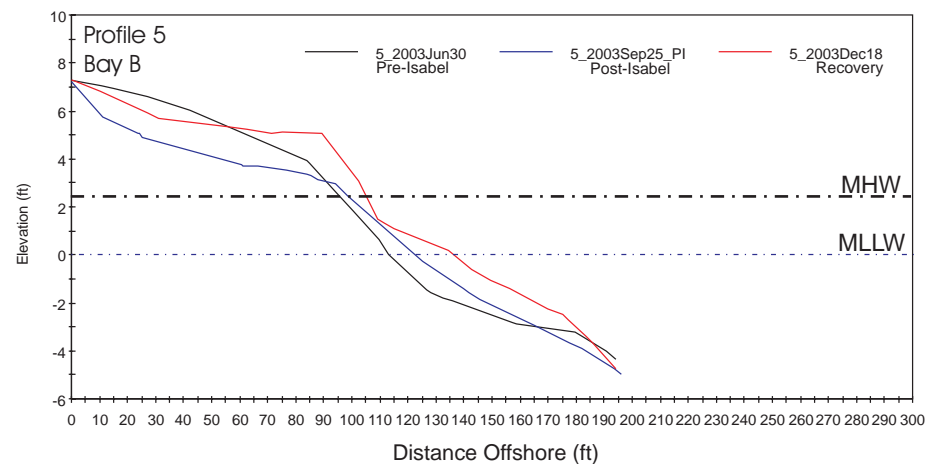
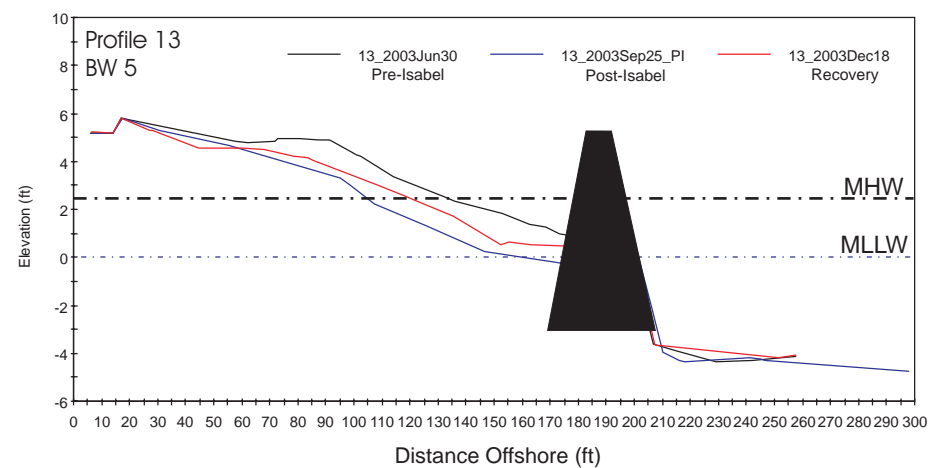
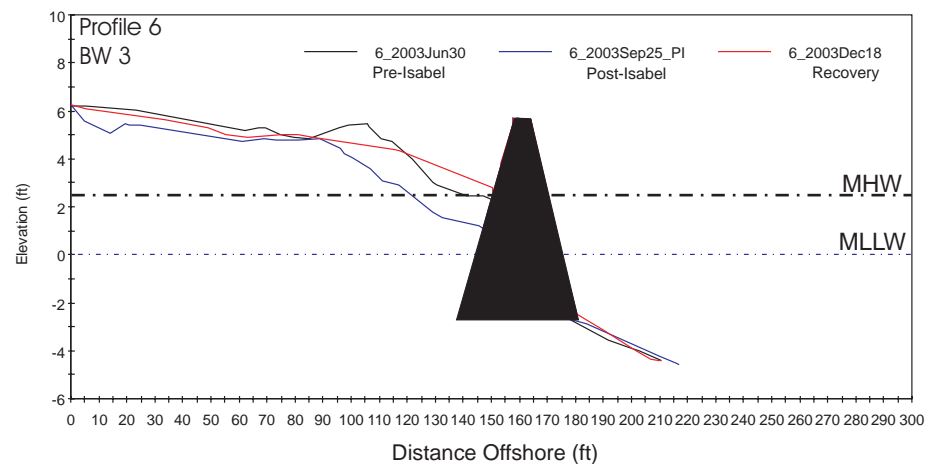
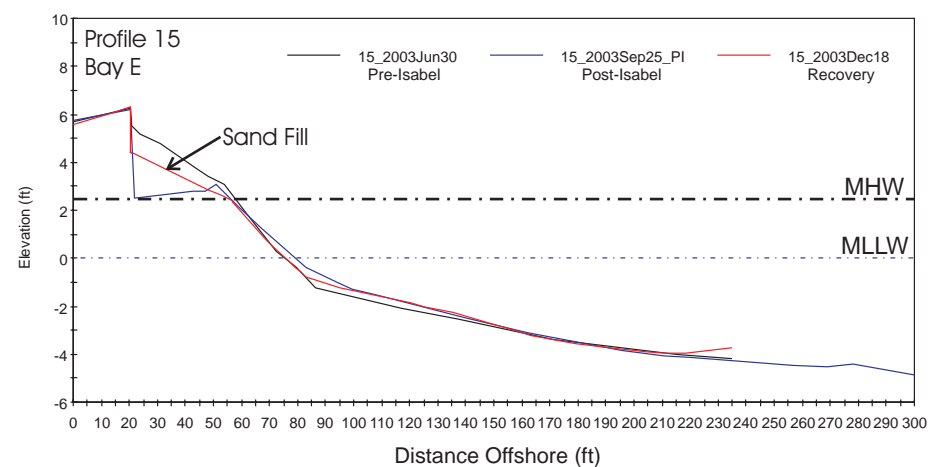
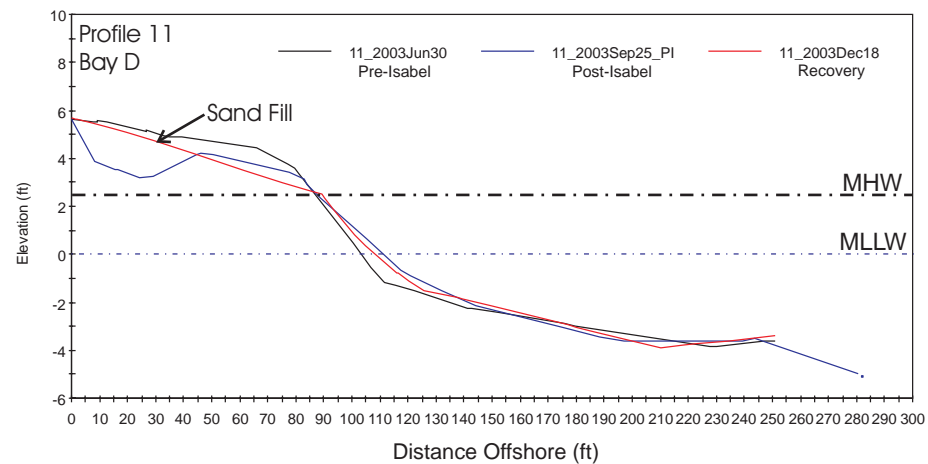
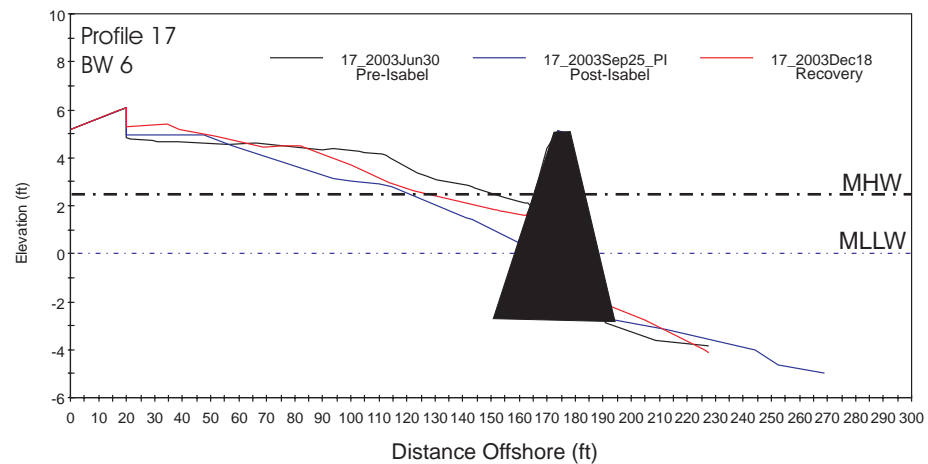
Figure 5. Selected pre- to post-Hurricane Isabel and recovery profile plots.

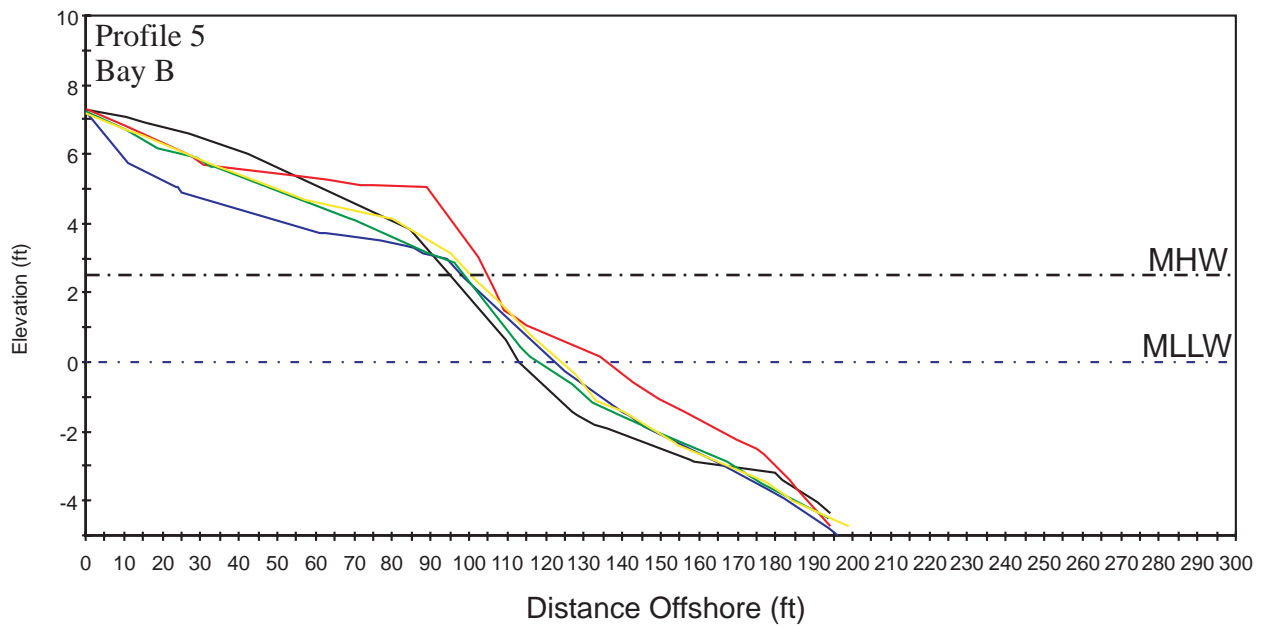
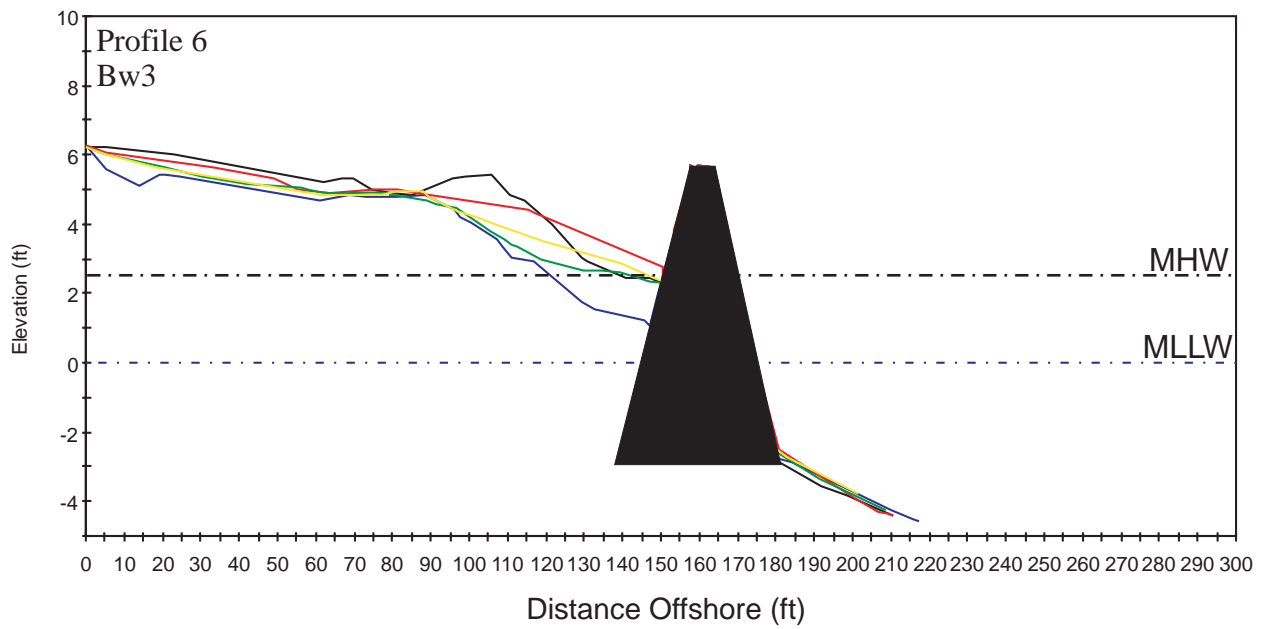
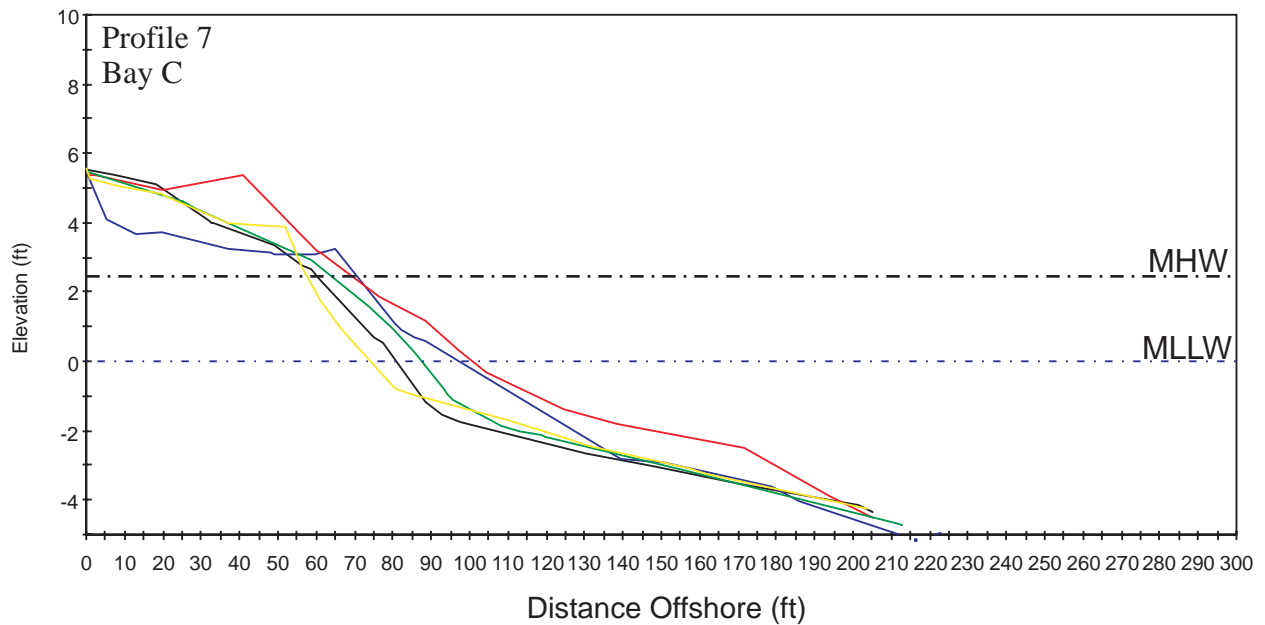
Figure 6. Selected plots of all profile dates.

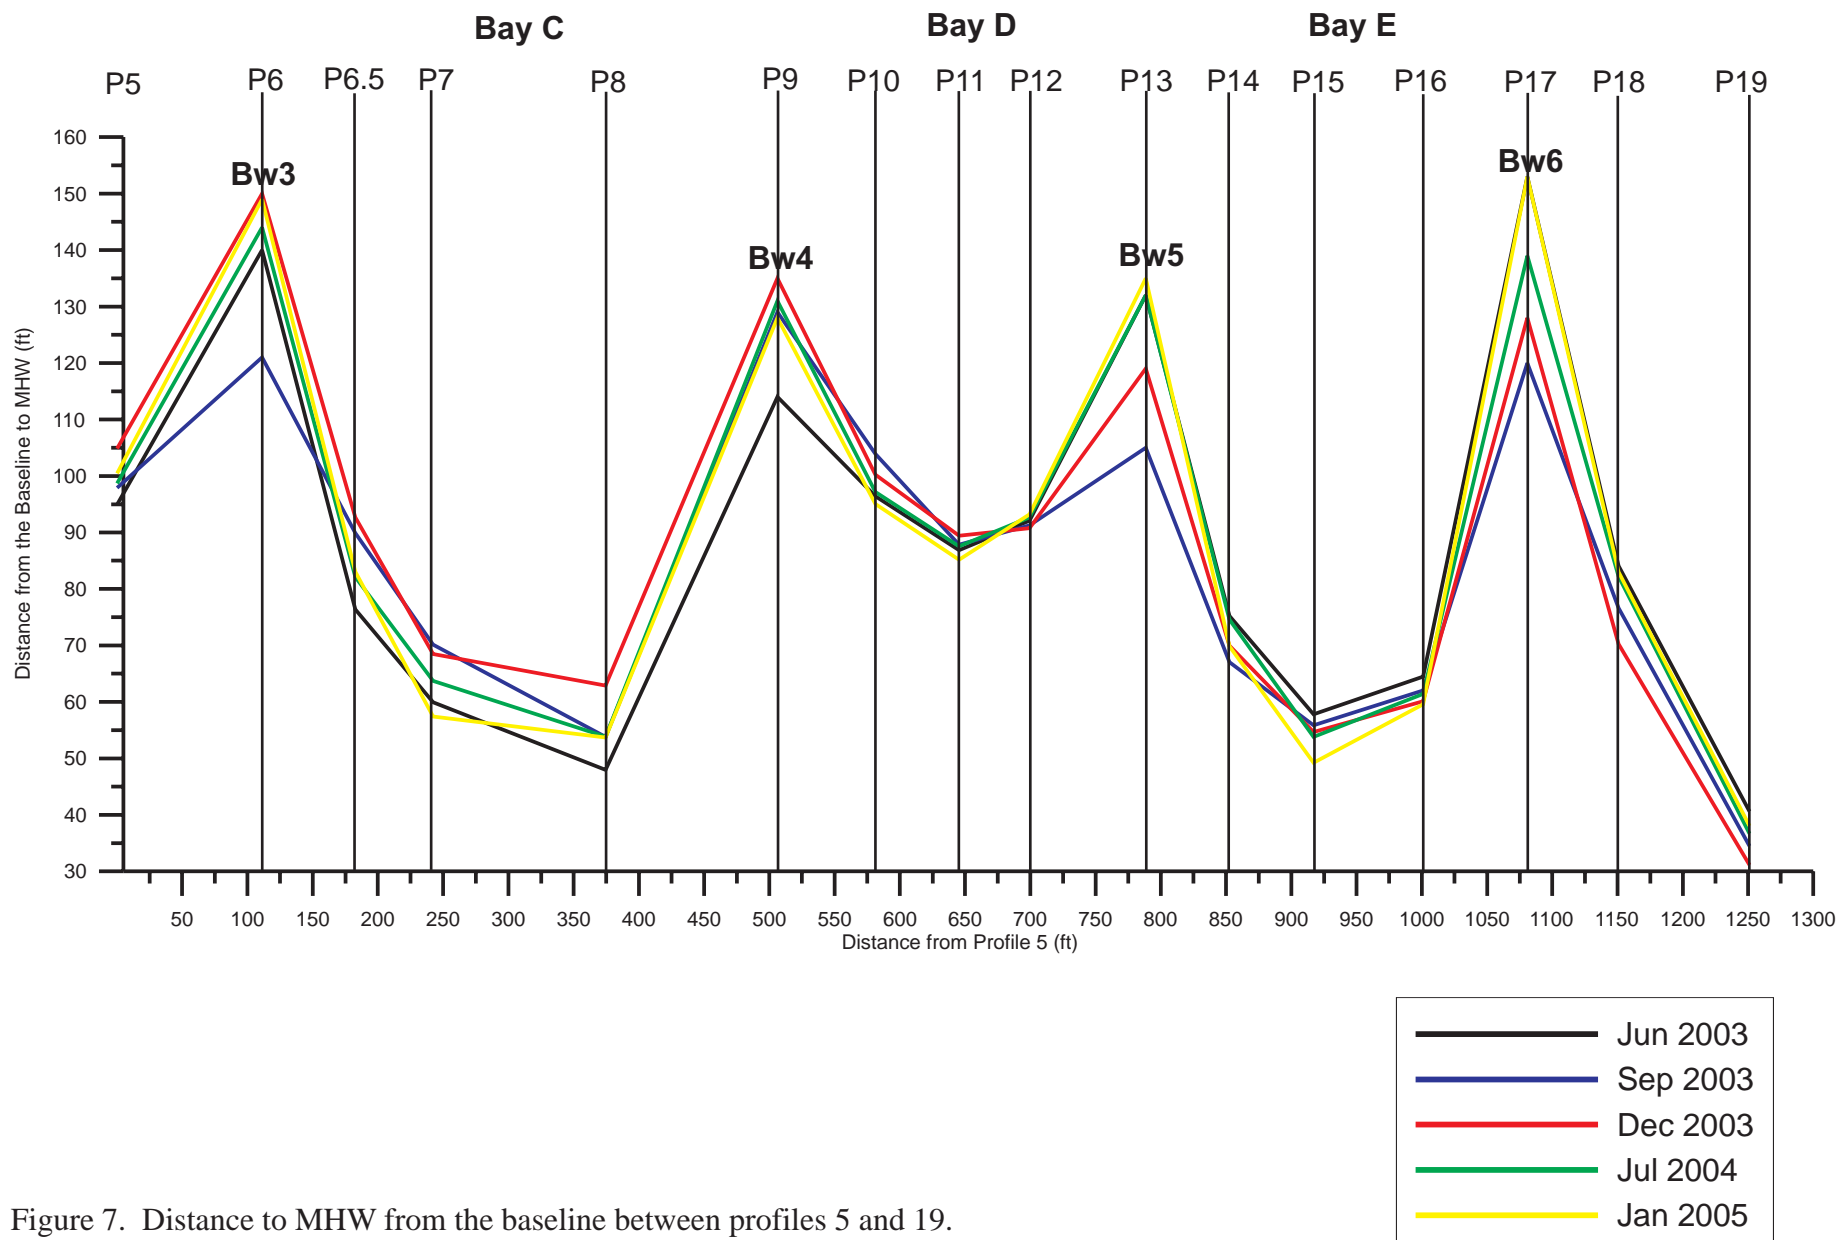
Figure 7. Distance to MHW from the baseline between profiles 5 and 19.

Distance to MHW from the baseline is commonly plotted to show the movement of the subaerial beach ([Figure 7](#)). In general, the position of MHW receded except for a few locations where a quantity of sand was eroded from the upper beach and deposited on the lower beach. The movement riverward of the position of MHW in December 2003 is due to the beach renourishment. Since that time the beach has been equilibrating as the sand shifts around the embayments.

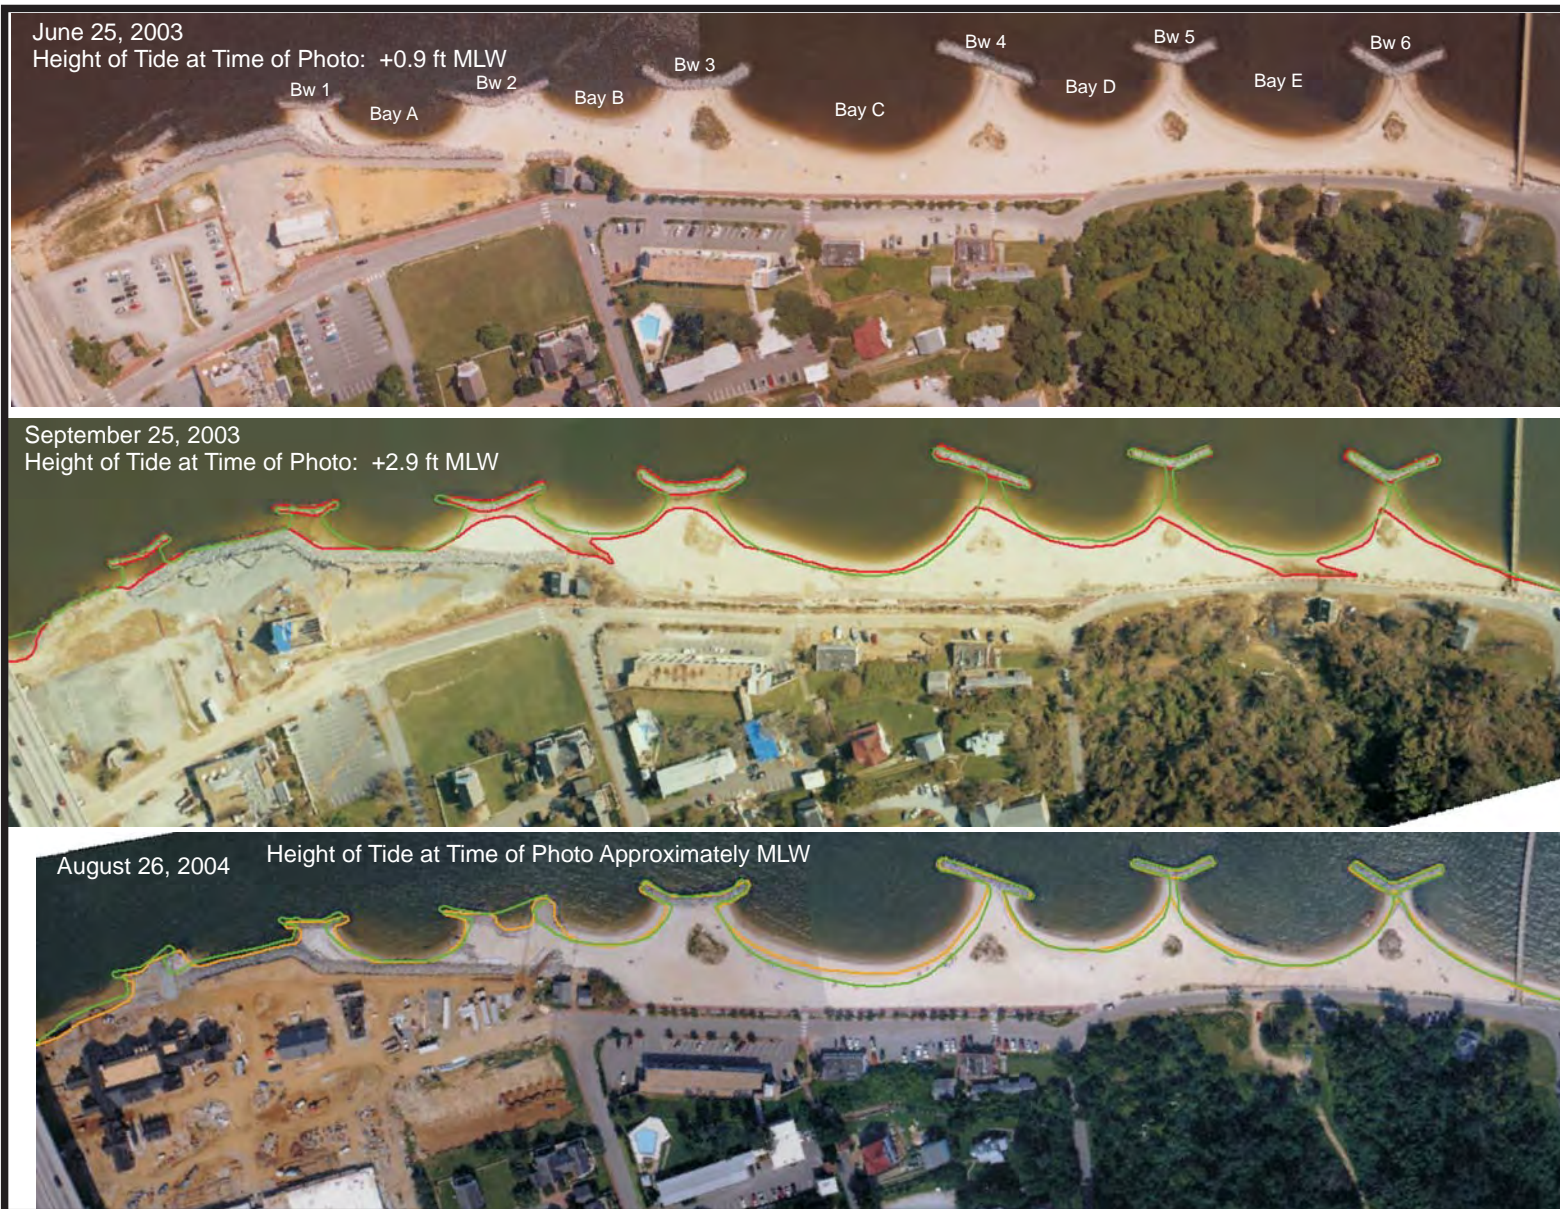
Figure 8. Yorktown low-level pre- and post-Hurricane Isabel and recovery ortho-rectified aerial photos.

Pre- and post-Isabel low level aerial imagery show a narrowing of each tombolo and a landward shift of sand behind each breakwater unit (Figure 8). The shoreline position in the two middle and largest embayments (Bays C and D) showed only slight changes after the storm. Post-storm recovery about one year later shows shore planforms to have returned to near their pre-storm position. A noticeable shore advance is seen in Bay C.

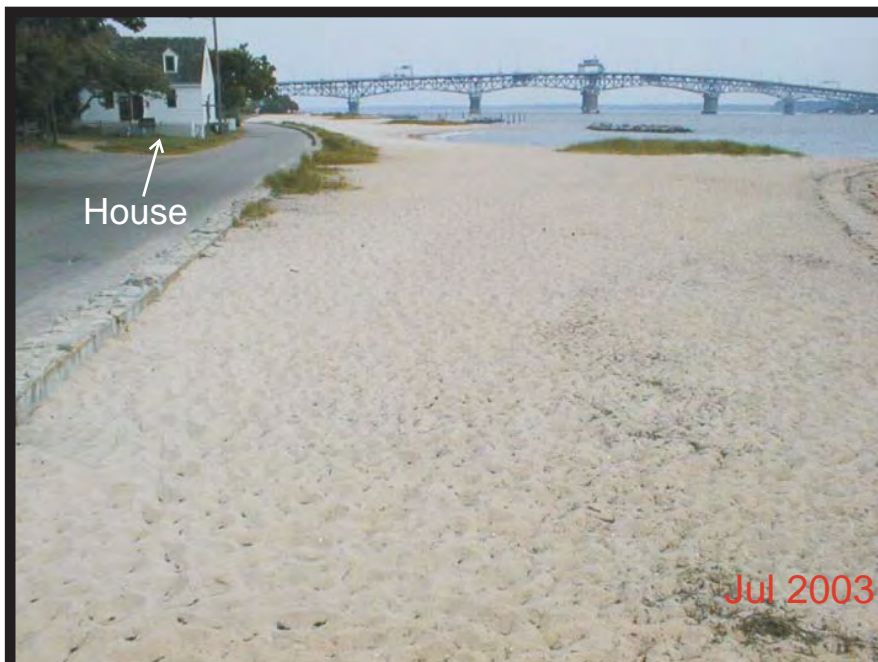
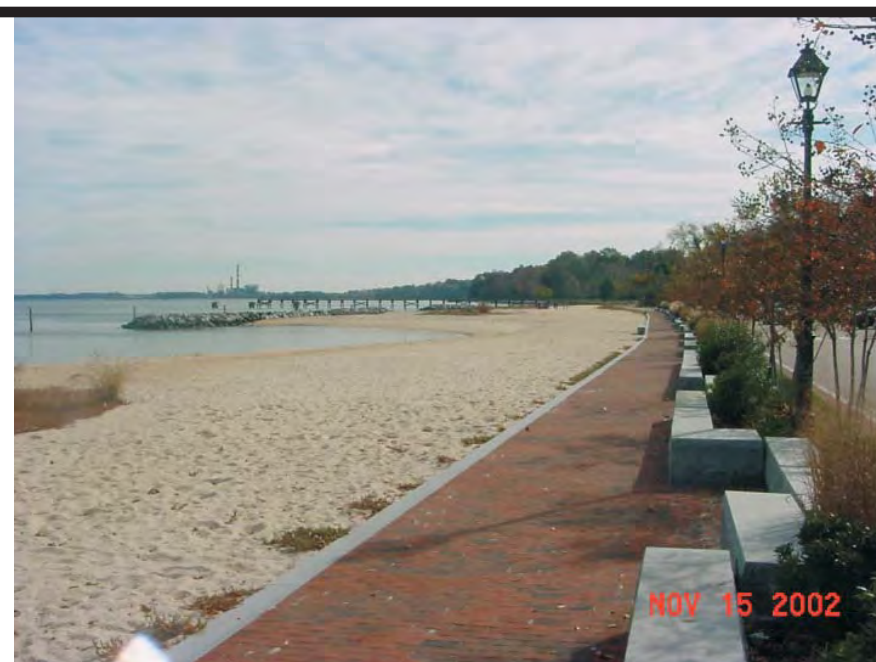
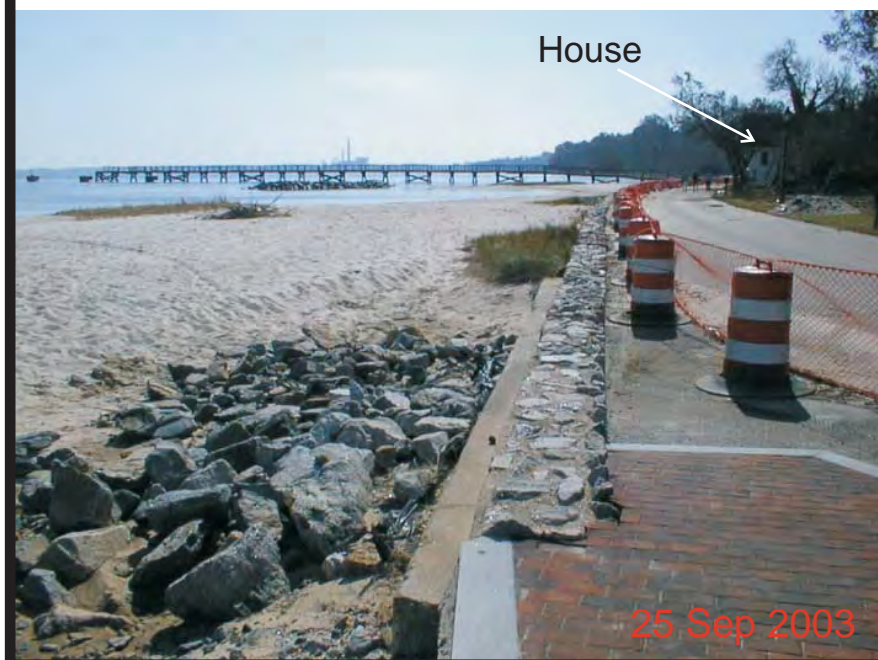
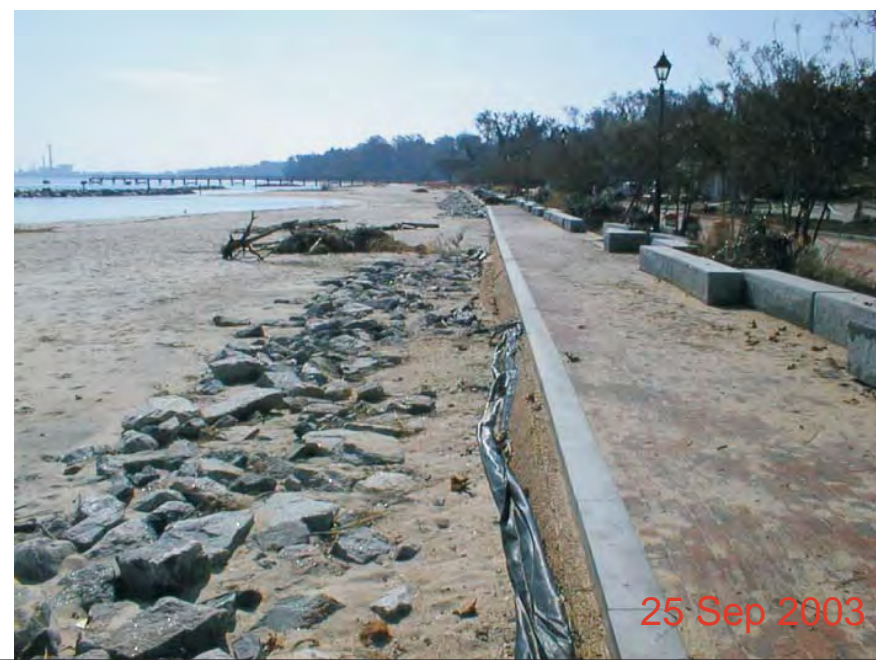
View along the downriver portion of Water Street

View along the upriver portion of Water Street at the main recreational area

Figure 9. Yorktown ground photos before and after Hurricane Isabel.

Historically, during storms, sand was carried into the adjacent street, but recent granite block "backstops" helped reduce this tendency during Isabel. These blocks measuring about 1 ft square, 5 feet long, and weighing about 1 ton were easily shifted around by the storm waves. Several areas of scour occurred along the backshore/sidewalk/road juncture exposing the underlying stone revetment (Figure 9). Post-storm clean up and added fill restored the public beach to use by late October 2003. The businesses along the waterfront were severely impacted by the high water, and it took several months for their rehabilitation, but they are presently operating. Figure 10 shows a low backshore along Water Street in Yorktown as well as the storm wrack lines which are the floating debris accumulated at the limit of high water. At Colonial National Historical Park, just downriver from Yorktown, small rocks from the revetment along the shoreline were scattered on the road, and the adjacent upland bank was severely scarped.

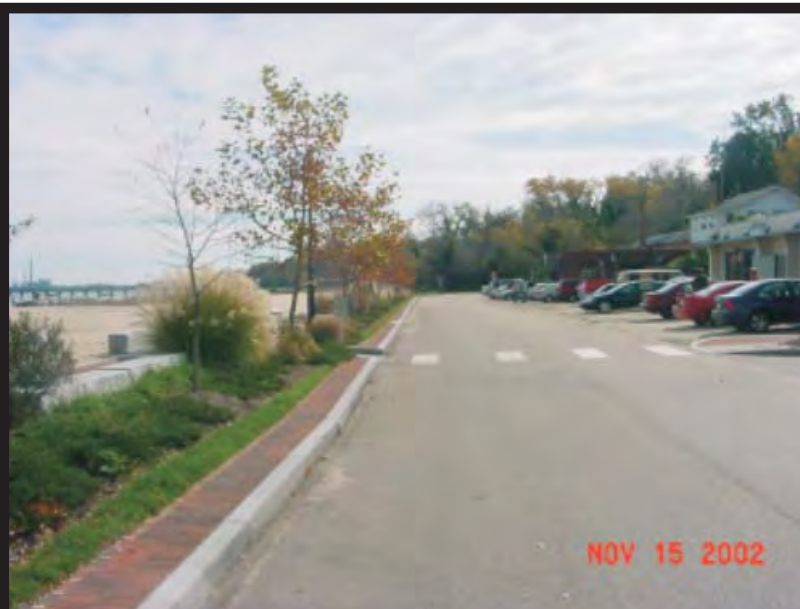
A
Pre-storm
low backshore

Figure 10. Yorktown A) backshore and B) post-storm wrack line and C) adjacent shore impacts.

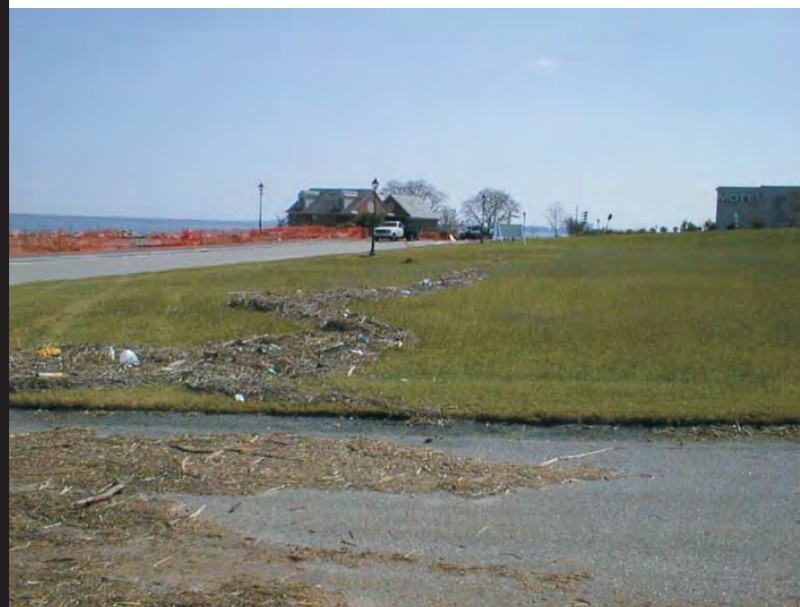
B
Post-storm
wrack line

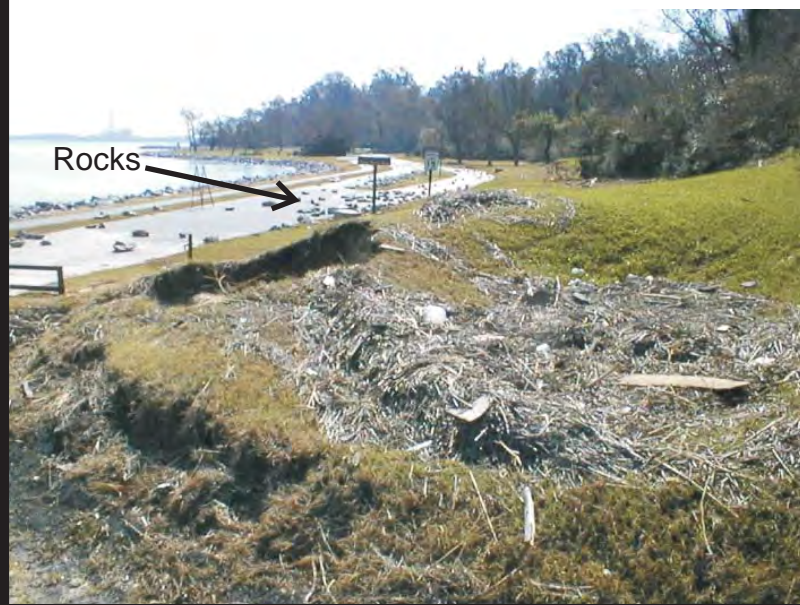
C
Post-storm
wrack line
downriver
